# South Saginaw Street Corridor Study

Prepared for:  
City of Flint Planning Department  
In Collaboration with:  
Michigan State University Urban Planning Practicum

April 2013

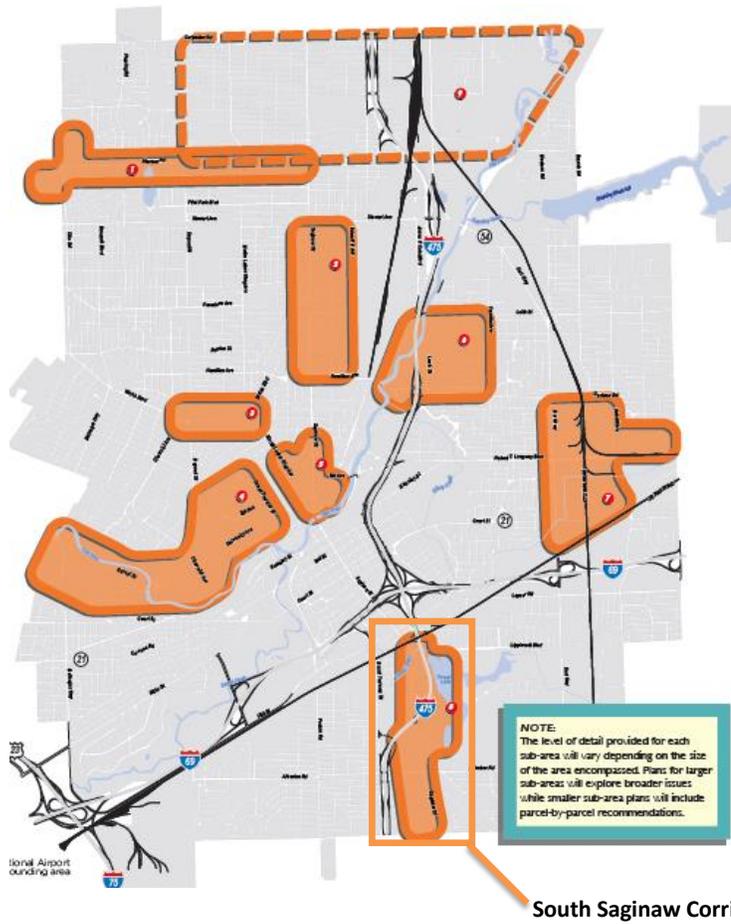
**Figure 1.1 Sub-Area Plans, City of Flint Master Plan Update**

For the first time in fifty years the city of Flint has begun revising its Master Plan, and is currently conducting various studies that will tie into the finished plan. Nine sub-area plans are being developed for inclusion in the Master Plan update, displayed in Figure 1.1. The South Saginaw Corridor has been designated as one of the nine sub areas. To help address issues of outdated planning and economics, the Practicum Team has been assigned to assist in revitalizing the South Saginaw Corridor. In their analysis of the South Saginaw Corridor, the practicum team hopes to contribute to the city's redevelopment by creating an inventory of the corridor featuring possible economic development strategies, streetscape beautification, an inventory of commercial parcels, existing infrastructure and roads, encouraged use of public transportation, and increases in mixed-use developments. It was critical that stakeholders such as businesses, consultants, city officials, and residents were continuously involved in the plan, thus the practicum team held public meetings with residents, business owners, and city planners to work towards a vision that everyone can agree with.

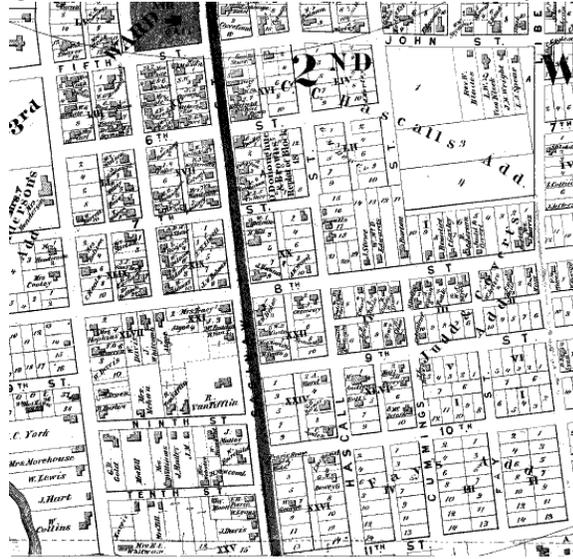
Figure 2.1: South Saginaw Street from an 1893 Atlas of Genesee County

The history of South Saginaw Street is closely intertwined and indicative of the history of Flint itself. As seen in Figure 2.1, South Saginaw Street (indicated on the map as a black line dividing the 2<sup>nd</sup> and 3<sup>rd</sup> wards of the village) developed quickly as the city continued to grow. Even though this map comes from an 1893 Atlas of Genesee County (Beers 2005), the parcels neighboring the street are densely developed. This trend continued, and South Saginaw Street cemented itself as a major thoroughfare for the city. However, as the downtown fell into a pattern of disinvestment, so did the arteries connecting to the downtown. Yet there still remain anchors within the corridor, including Diplomat Pharmacy, the International Academy of Flint and Applegate Chevrolet Company.

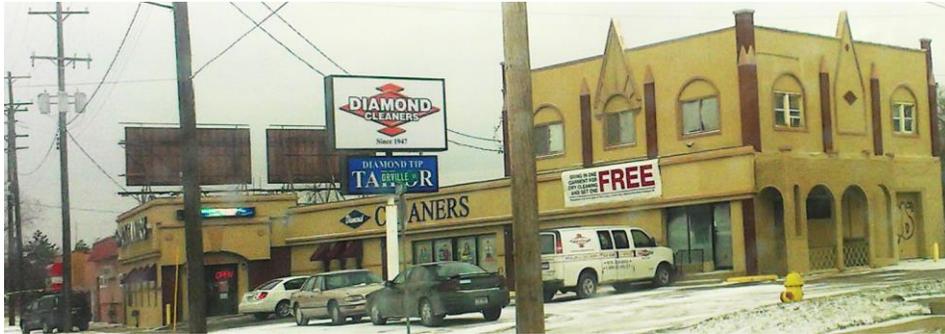
Figure 2.5: Example Building 1	Condition	Score	Assessment
Diamond Cleaners 2147 S Saginaw St	Good	1	The Diamond Cleaners property has been recently renovated, and has a unique, historic façade, good window conditions, a clean, well-kept lot, and a clearly marked sign for the business.

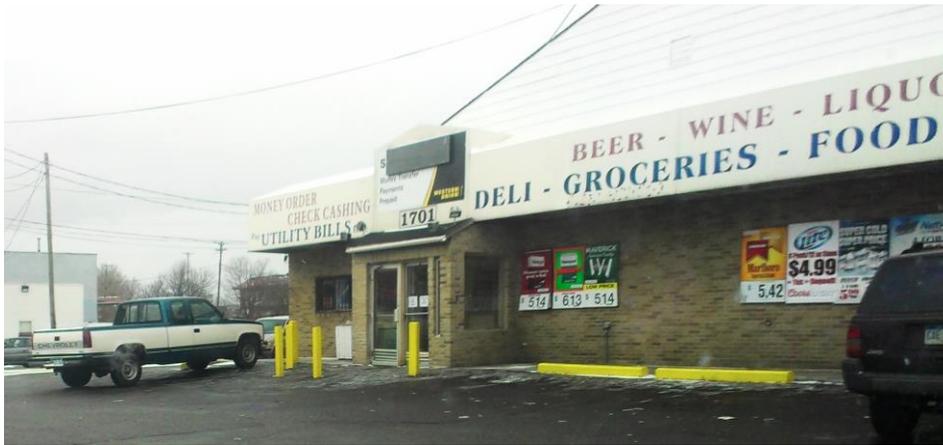
Figure 2.6: Example Building 2	Condition	Score	Assessment
Beer – Wine – Liquor 1701 S Saginaw St.	Fair	2	The liquor store located at the intersection of S. Saginaw Street and 12 <sup>th</sup> Street exhibits an aged awning, minor cracks in the masonry, and a fairly plain façade, however it also is fairly well-maintained and has good window conditions.

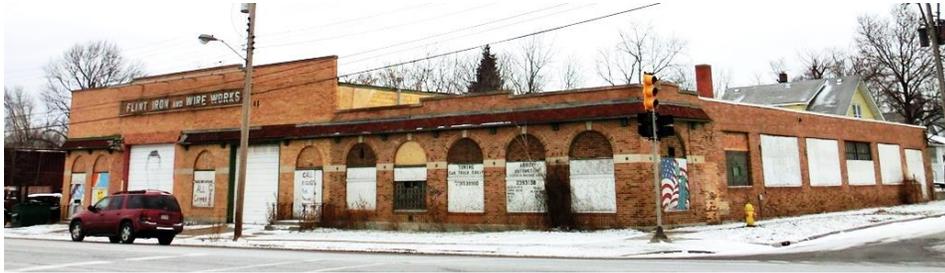
Figure 2.7: Example Building 3	Condition	Score	Assessment
Flint Iron and Wire Works 3205 S Saginaw St	Poor	3	It is unclear whether this industrial parcel is currently in operation, with a majority of the windows boarded up, some major cracks in the masonry, and a degraded historic façade gives this building a poor grade.

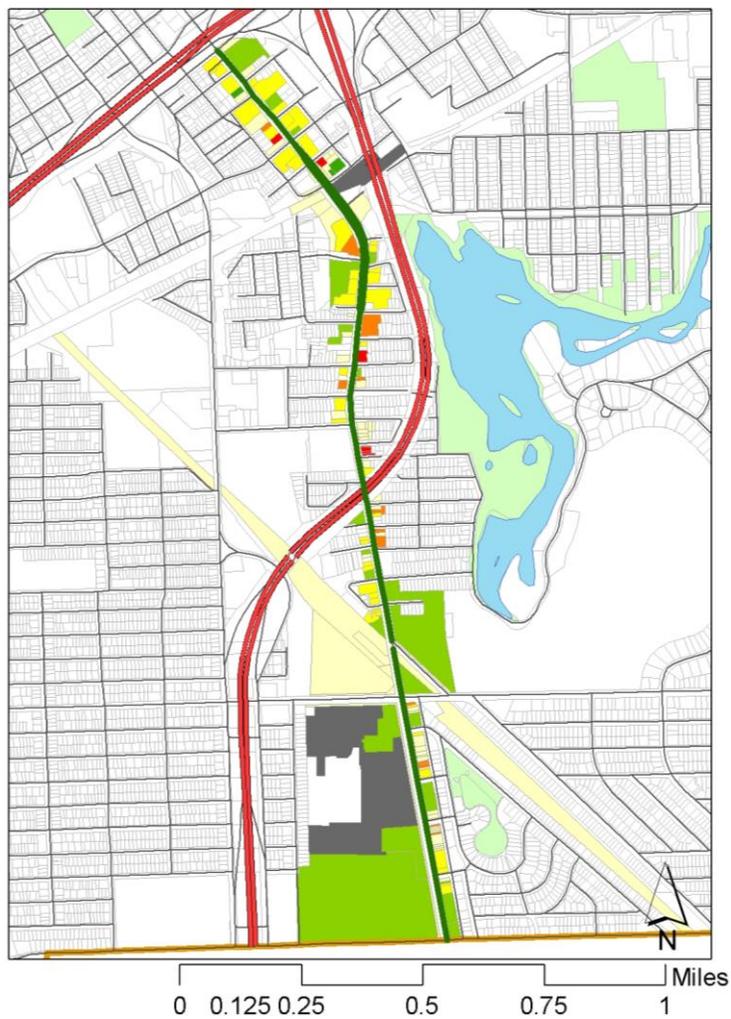
**Figure 2.15: South Saginaw Corridor Road Conditions**

South Saginaw Street exhibited excellent features for road condition, with the road surface and curbs well maintained, and lines clearly painted. It appears as if South Saginaw Street was resurfaced within recent years. The City of Flint Road Commission maintains South Saginaw Street, and has kept abreast of repairs to both road surface and curbs. The results are pictured in Figure 2.15. However, this is not to say that more efforts cannot be made to improve the quality of the roads within the study area. In the following sections we will address modifications that could be undertaken to improve the safety and commuting experience for all users of South Saginaw Street.

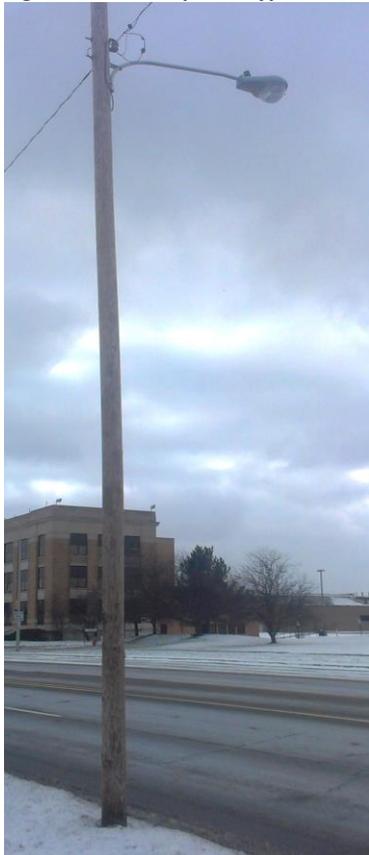
**Figure 2.16: Example of Typical Streetlights along South Saginaw Street**

The Street Lighting survey found that the lighting levels within the study area were fair, with an average score of 2.31. Most of the lighting was in functioning order, with adequate lighting found predominantly within the study area. However, while these lights are functional, they lack aesthetic appeal. The majority of the streetlights within the study area were mounted on telephone or utility poles, rather than metal light poles. This affected the general aesthetic score for the majority of the study area; however the southern-most blocks offer more aesthetically pleasing lighting fixtures on the western side of Saginaw Street. Conversely, the same low-ranking site detailed in the sidewalk condition report, the block directly under Interstate 475, again received the only deficient score. This block did not feature any lighting underneath the busy underpass, and lies directly adjacent to the charter academy. The street lighting conditions for each of the sections of the corridor are displayed in Figure 2.17.

In order to create uniform and visually appealing street lighting that signifies the South Saginaw Corridor and provides safety for residents, street lighting should be a major short-term priority for the city's Planning Department. Increased lighting in urban areas drastically reduces crime rates and creates safer areas. Attractive and well-lit streets also help to build the character of neighborhoods, yet much of the street lighting on the South Saginaw Corridor does not build the character of the area as many streetlights are worn out and do not function with the overall streetscape.

- Remove deteriorating streetlights that do not uplift the character of the South Saginaw Corridor and replace them with lighting that build the character of the corridor.
- Safety of residents should be a major priority for city officials therefore; all street lighting should be well maintained in order to ensure safety.
- Work with city planners and other city officials to create a standardized system of streetlights that will be used throughout the corridor.

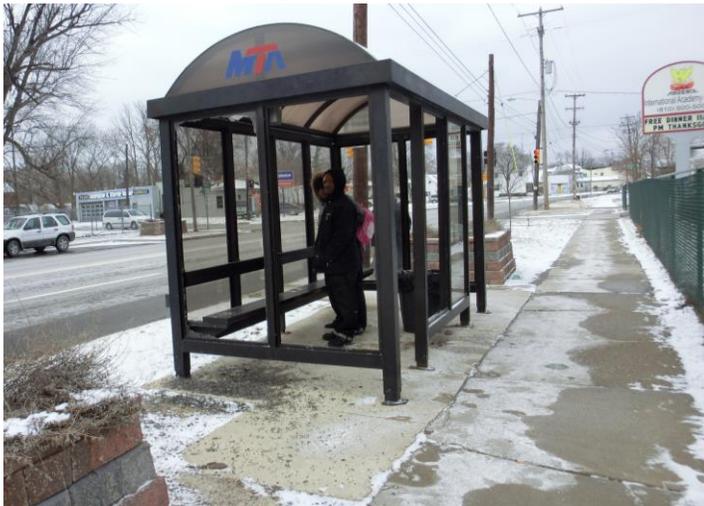
Figure 2.18: MTA Transit Stop, South Saginaw Street

Transit stops throughout the study area were generally without amenity. The bus stop located adjacent to the International Academy of Flint was the most well equipped transit stop within our study area. However, even this stop is not well maintained by the MTA, as it is missing numerous panes of glass and is generally dirty. Also, the transit stop does not include any route information, or additional seating outside of the shelter (Figure 2.18). This is typical of stops within the study area, as most were only distinguishable by small metal “MTA” signs attached to poles. This makes public transportation difficult for residents who are unfamiliar route schedules or directions.

- Bus stop shelters should be well maintained by the proper authority. Repairs should be expedited.

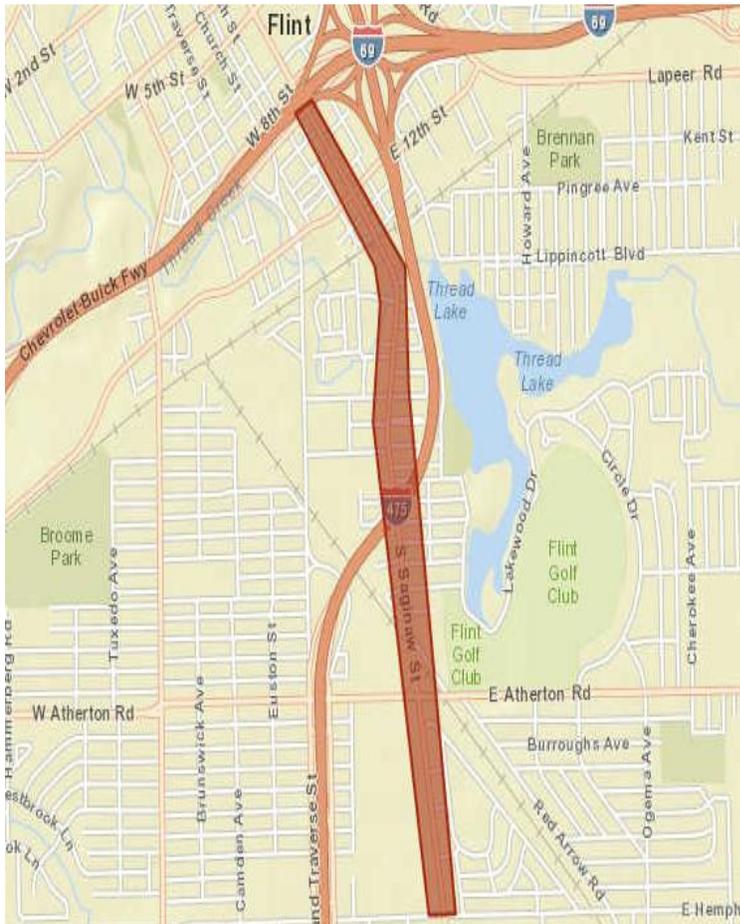
**Figure 4.2: Market Analysis Study Area**

The same study area was utilized for this analysis, with Interstate 69 and Hemphill Road providing the northern and southern extents, with a one-block buffer placed on either side of South Saginaw Street. This buffer was included to incorporate all businesses that are located on the corridor. The study area is depicted in Figure 4.2.

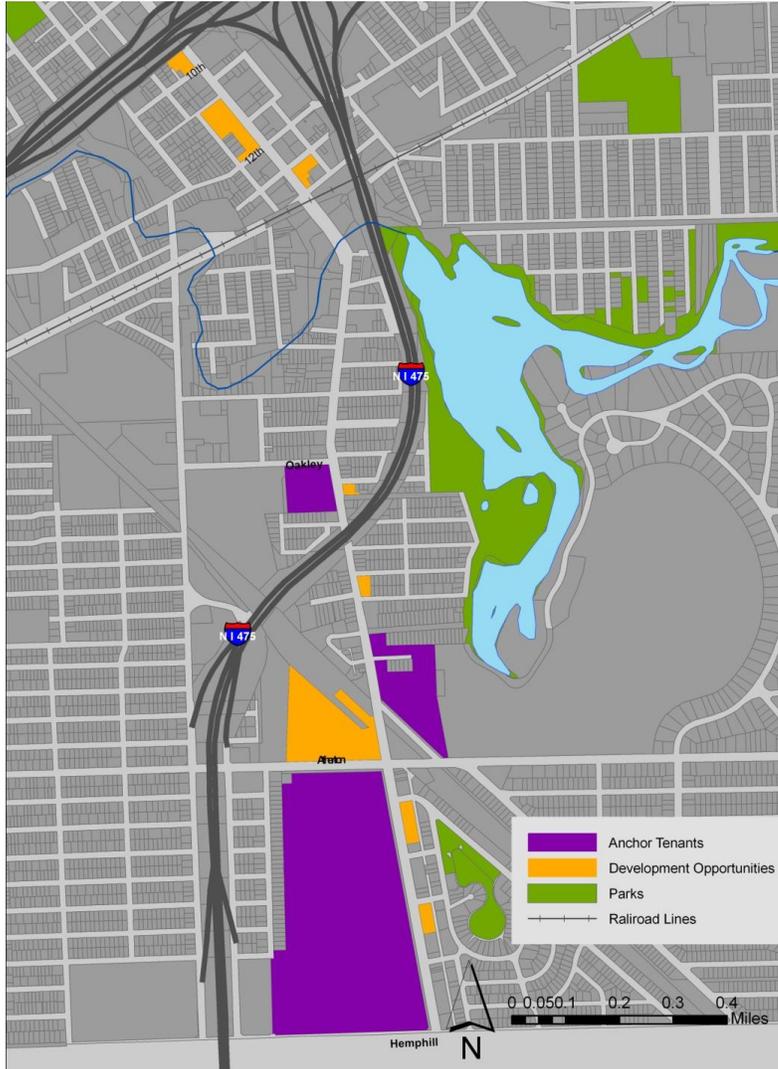
Figure 5.1: Anchor Tenants and Potential Redevelopment Opportunities

The South Saginaw Corridor features a number of assets to work with, including such anchors in the community as Diplomat Pharmacy, The International Academy of Flint, and Applegate Chevrolet. These long-time members of the community have demonstrated great resolve in their continued presence.. If possible, these assets should be developed upon and expanded by strengthening the vital areas of the corridor. These areas have been identified as the blocks adjacent from Diplomat Pharmacy, the blocks neighboring the International Academy of Flint, and the 12<sup>th</sup> Street Intersection (Figure 5.1). The first two areas were identified based on their proximity to an anchor tenant, and the low quality of the building stock in the surrounding homes and businesses. The 12<sup>th</sup> Street Intersection was identified as a possible opportunity for redevelopment of several severely blighted properties, which would strengthen the corridor and provide a gateway to the downtown. Stakeholder interviews and questionnaire forms were used to obtain public feedback on corridor redevelopment goals, priorities, and recommendations. This insight was used to understand the community's perceptions of the effectiveness and shortcomings of the ongoing redevelopment efforts, while also providing their vision for the community moving forward.

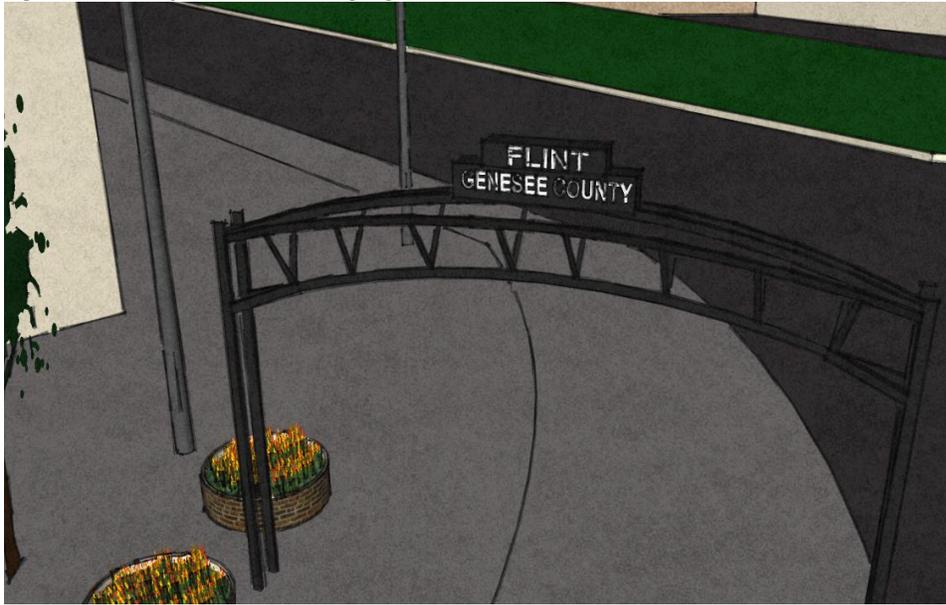
Figure 5.4: Example of Potential Signage

- These efforts by the city hopes to stimulate private façade and signage reinvestment.
- Install welcome signage at the boundaries of the South Saginaw Corridor. The practicum team has developed two signage examples to provide insight into future signage enhancements. The first example is a miniaturized version of the current archway the city installs (Figure 5.4). These archways should be large enough to be seen by motorists, yet remaining relatively small and cost effective. The second example is simply continuing the city’s current archways and dimensions, but with only two locations.
