# Rebuilding an Eroding Bank on an Inland Lake

## *A Comparison of Traditional and Prefabricated Encapsulated Soil Lifts*

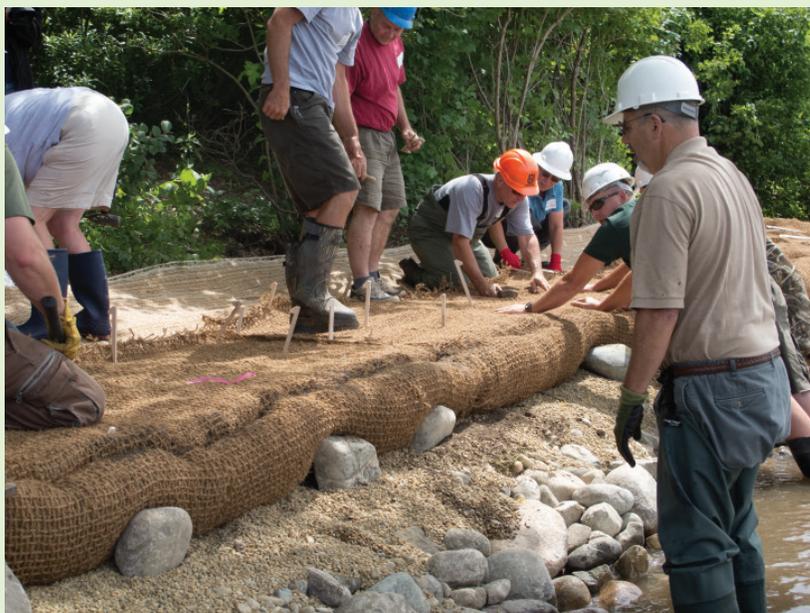
**Figure 1.** Workshop participants install a prefabricated soil lift at Kellogg Biological Station near Hickory Corners, Michigan, in July 2011. The participants were Certified Natural Shoreline Professionals (CNSPs) who earned continuing education units by installing traditional and prefabricated ESLs for this comparison study during a one-day workshop. You can watch a brief video about the installation at [www.shoreline.msu.edu/shorelinemgt/natural-shoreline-constructing-encapsulated-soil-lifts/](http://www.shoreline.msu.edu/shorelinemgt/natural-shoreline-constructing-encapsulated-soil-lifts/).

The flagship educational program of the Michigan Natural Shoreline Partnership (MNSP) is the Certified Natural Shoreline Professional (CNSP) program. CNSP is a certification training for shoreline contractors who want to expand their business services to include natural shoreline landscape design and bioengineered erosion control. To maintain their certification, CNSPs must successfully complete MNSP-approved continuing education activities. More technically challenging than the basic bioengineering techniques taught during the certification training, building encapsulated soil lifts (see fig. 1) is an appropriate activity for CNSP continuing education.
