# 2013 City of Owosso S. Washington St. Corridor Study

Our goal is to enhance the corridor between Baker College and downtown Owosso by focusing on the built environment including connections, gateways, and the streetscape.

# The Boundaries

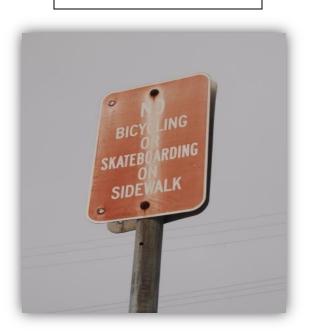
Example Score: Poor

<i>c</i> .	Poor - Little to no signage in the area; existing signage either damaged or worn.
	Fair - Some signage exists and is visible from multiple modes of transportation
	Good - A full wayfinding system has been implemented; signage is completely visible from all modes of transportation

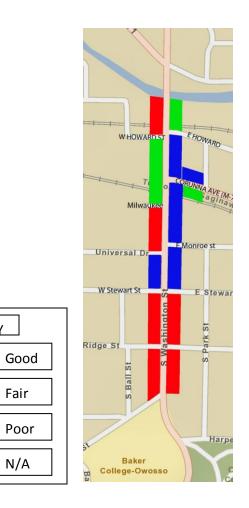
Signage		
West Side of S Washington - Gute to Ridge	Poor	
East Side of S Washington - Gute to Ridge	Poor	
West Side of S Washington - Ridge to Stewart	Poor	
East Side of S Washington - Ridge to Stewart	Poor	
West Side of S Washington - Stewart to Universal	Fair	
East Side of S Washington - Stewart to Monroe	Fair	
West Side of S Washington - Universal to Milwaukee	Poor	
East Side of S Washington - Monroe to Corunna	Fair	
West Side of S Washington - Milwaukee to Howard	Good	
East Side of S Washington - Corunna to Howard	Fair	
West Side of S Washington - Howard to River	Poor	
East Side of S Washington - Howard to River	Good	
North Side of Corunna Ave – S Park St to Washington St	Fair	
South Side of Corunna Ave – S Park St to Washington St	Good

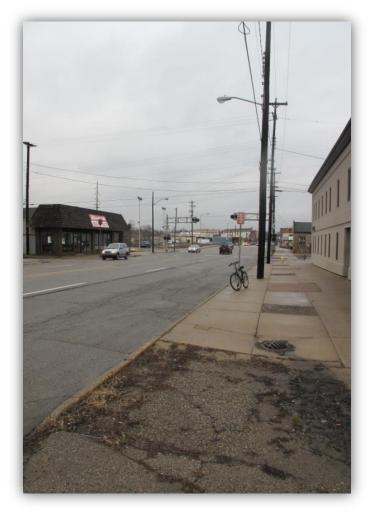
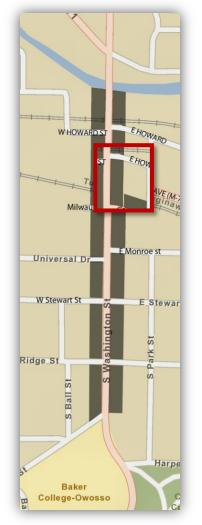
#### Block-By-Block Analysis EAST SIDE OF S WASHINGTON - CORUNNA TO HOWARD

Sidewalk Conditions	Good
Sidewalk Width	5 ft
Obstructions	Poor
Handicap Accessibility	Poor
Signage/Wayfinding	Fair
Landscaping	Poor
Lighting	Fair
Bike Lane	Poor
Traffic Flow	25 mph
Street Parking	Poor
Housing Conditions	Good
Setback	Small

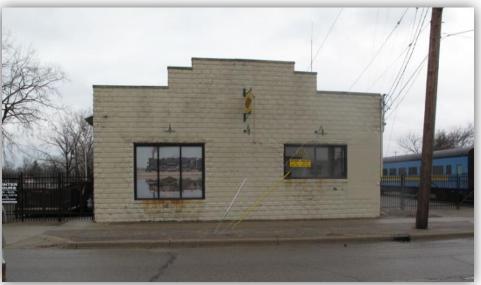
#### Steam Railroading Institute

Current Zoning	Institutional: Private
Future Land Use	Planned Unit Development
Setback	Small
Façade	Poor
Access Management	Poor

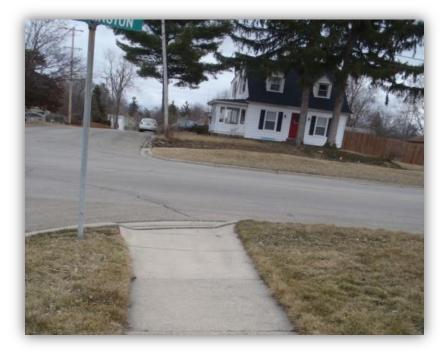
Example Score: Poor

Intersections	Delineation/Connection	Poor - The crosswalks do not have a connection point on the opposing side of the street.
		Fair – The Crosswalks are not marked by paint, or the paint has faded. There are no guidelines for pedestrians.
		Good - The boundaries of crosswalks are marked with thick white lines; pedestrians can locate the crosswalk and stay out of danger from vehicular traffic.
	Crosswalk Signal/Signage	Poor - Crosswalk Signal signage is not present; pedestrians are left guessing as to when it is safe to cross the intersection.
		Fair - Crosswalk signage has been implemented for some directions of pedestrian traffic.
		Good - Pedestrian Signal/Signage has been implemented for crosswalk for each direction of traffic

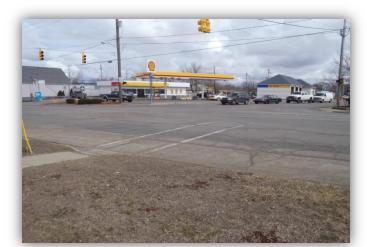
## Example of CORUNNA AVE AND S WASHINGTON ST

- CROSSING CORUNNA AVE
  Delineation/Connection: Good
  Crosswalk Signal/Signage: Good

CROSSING WASHINGTON ST
 Delineation/Connection: Good
 Crosswalk Signal/Signage: Good
