In-vessel composting of animal tissue

Dale Rozeboom, Todd Miller, Bradley Pietila

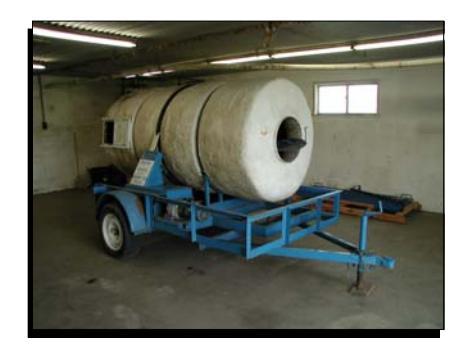
In-vessel Model 0824 (8' long, 36" diameter, 24 yd^3 capacity) has been used. The vessel consists of an insulated drum which is mounted on rotor casters. The drum is rotated by a chain drive approximately one complete rotation per 20 minutes. Materials are loaded and exit through ports at the ends of the drum. The drum is mounted at an incline to a steel frame resulting in the movement of the compost material from one end to the other as it rotates.

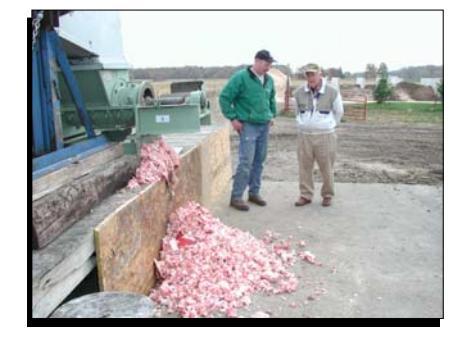
From May 25 to July 13, 2006, we composted one batch of 589 lb. ground by-product and 569 lb. of amendment (103 lb. dry bagged shavings at about 10% moisture and 466 lb. dairy gestation bedding.

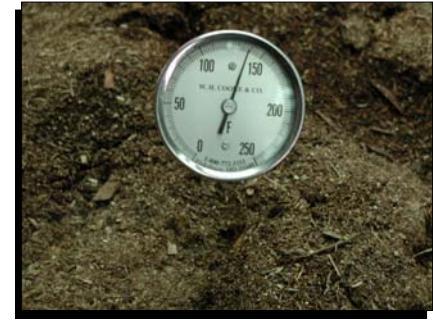
Temperatures of 130 to 150 degrees F were recorded each week. They decreased to 80 to 90 degrees F each week as well. The cessation of composting activity was a result of the compost becoming too dry (as little as 10% H_2O); due to evaporative moisture loss. To restart compost activity, 35 to 85 gallons of water were added at a rate of 1 gallon per 33 seconds or less to avoid leachate release from the IV unit.

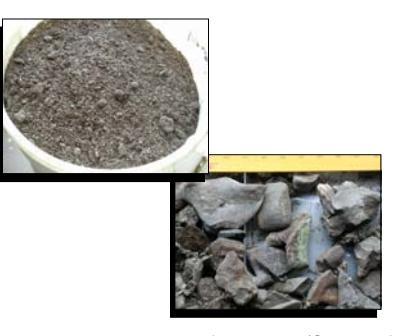
Finished compost was not fully cured (Solvita of 3, still very active). Other characteristics:

Carbon, %	47.1
Nitrogen, %	2.3
Calcium, %	2.9
Phosphorus, %	1.4
Sulfur, %	0.16
Iron, ppm 12	2548
Aluminum, ppm	125

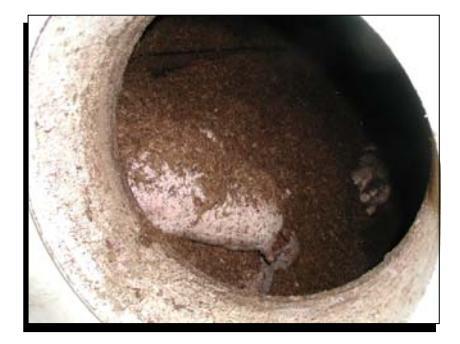
From May 13 to August 21, 2007, we composted swine mortality from the MSU Swine Farm on a continuous flow basis. Over that time 576 lb. of mortality (carcass sizes 8 to 146 lb.), 440 lb. of dry bagged shavings (10% moisture), 7 lb. urea N, and 146 lb. fresh hog manure solids were added overtime.

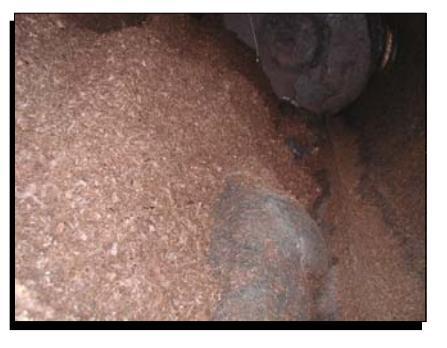
Carcasses decomposed quickly, becoming darker in color in just 3 days. Soft tissue was not recognizable in about 10 to 14 days.

We struggled to maintain activity and did not obtain desired 130 to 150 degree F temperatures on a weekly basis. Estimated C:N ratio was about 15 and may have been too low.

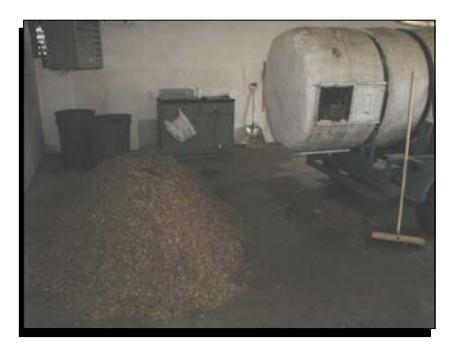
Because of the decreased activity, we observed less volume reduction over time. We decided to empty the IV unit after 12 yd³ of compost material was accumulated in the IV unit and desired temperatures could not be achieved.

It was more difficult to operate the IV unit and achieve consistent active decomposition on a continuous flow basis

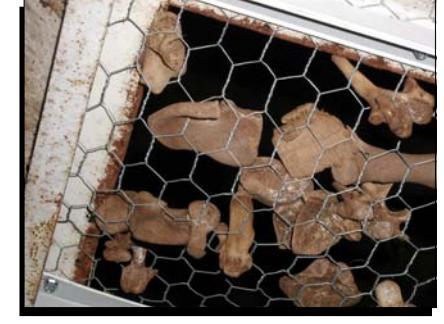
Screens were fabricated for the 3 exit doors using 1 inch chicken wire fencing. When the IV unit was emptied, the screen effectively prevented larger bones from being removed.
