Rebuilding an Eroding Bank on an Inland Lake

A Comparison of Traditional and Prefabricated Encapsulated Soil Lifts

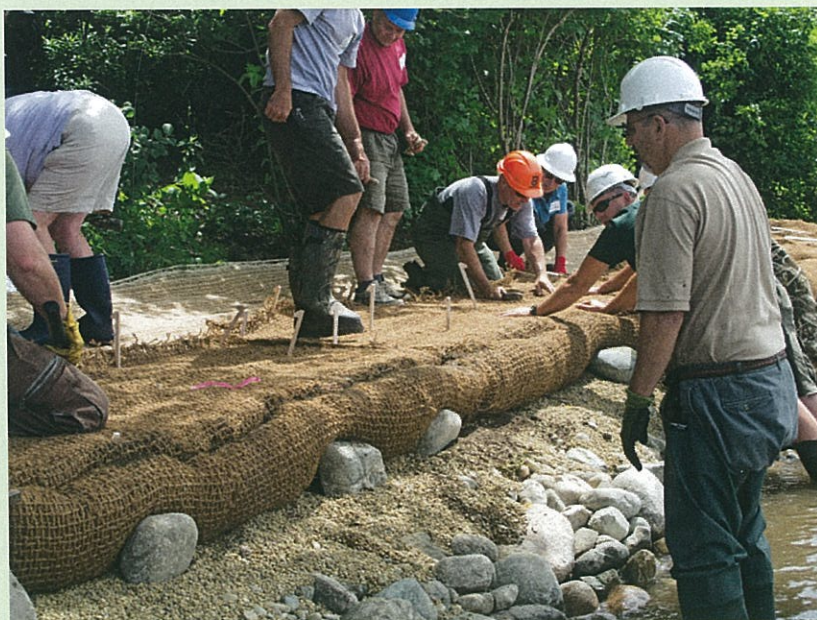
Figure 1. Workshop participants install a prefabricated soil lift at Kellogg Biological Station near Hickory Corners, Michigan, in July 2011. The participants were Certified Natural Shoreline Professionals (CNSPs) who earned continuing education units by installing traditional and prefabricated ESLs for this comparison study during a one-day workshop. You can watch a brief video about the installation at www.shoreline.msu.edu/shorelinemgt/natural-shoreline-constructing-encapsulated-soil-lifts/.

The flagship educational program of the Michigan Natural Shoreline Partnership (MNSP) is the Certified Natural Shoreline Professional (CNSP) program. CNSP is a certification training for shoreline contractors who want to expand their business services to include natural shoreline landscape design and bioengineered erosion control. To maintain their certification, CNSPs must successfully complete MNSP-approved continuing education activities. More technically challenging than the basic bioengineering techniques taught during the certification training, building encapsulated soil lifts (see fig. 1) is an appropriate activity for CNSP continuing education.
